# SYLWRAP Case Study

## Cast Iron Soil Pipe Leaking Above Hospital Ward

A 2-metre long horizontal crack in a 150mm cast iron soil pipe is sealed within 30 minutes of wastewater beginning to drip through a roof into a hospital ward

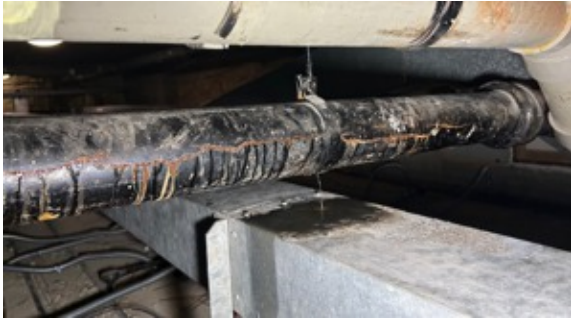
Wastewater was leaking through a 2-metre horizontal crack in the cast iron pipe, located above a ward

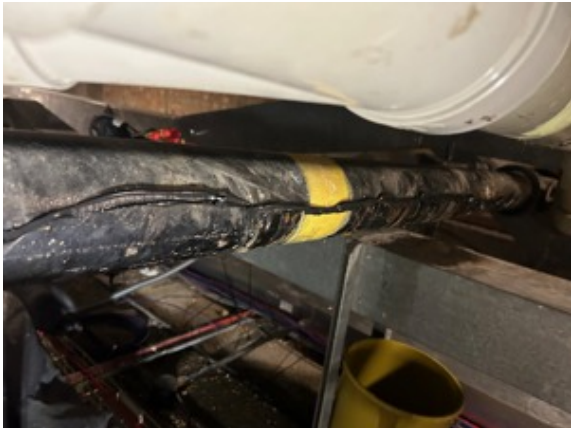
CrackSeal was extruded directly into the crack, hardening inside almost instantly to seal the leak

CrackSeal was extruded directly into the crack, where it hardened almost instantly - despite the wet surface and wastewater continuing to leak through.

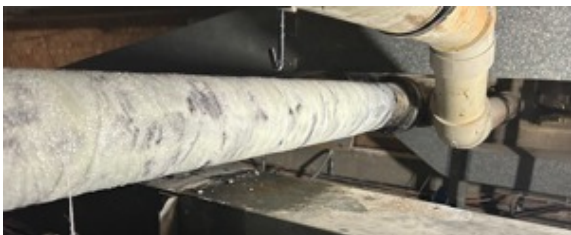
Two SYL633HD SylWrap Bandages were used to reinforce the CrackSeal repair

Two SYL633HD **SylWrap HD Pipe Repair Bandage** were then wrapped along the entire repair area, reinforcing the pipe with a rock-hard outer shell.

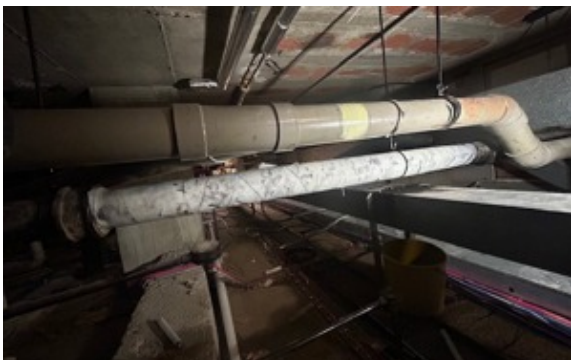
SylWrap provided a rock-hard, impact resistant sleeve across the entire section of cast iron pipe
