SUPERFAST **AQUA PW STICK**

Case Study

Production Facility HVAC Cooling Tower Repair

After several failed repair attempts, a leaking HVAC cooling tower on the roof of a production facility in the USA is sealed within a matter of hours

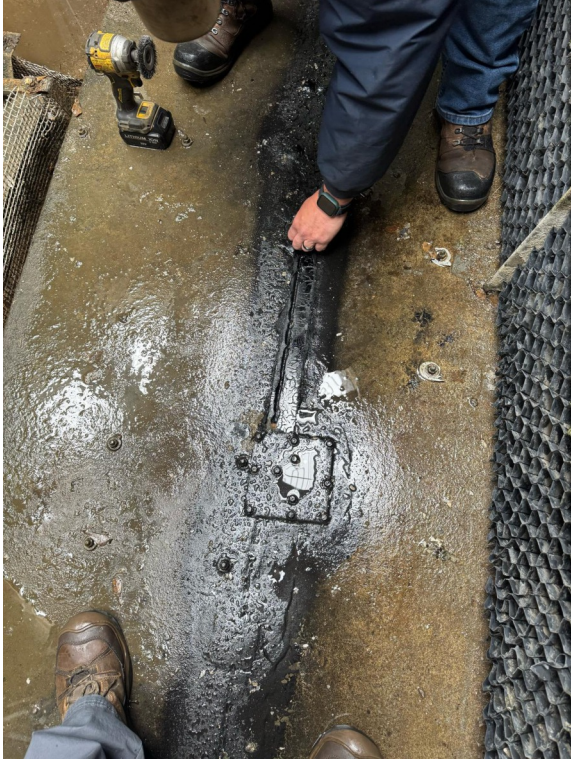
The floor of the cooling tower was leaking through a crack with further damage to the concrete either side

After water was seen leaking from the tower, it was drained and accessed. A long crack was found in the floor, with significant amounts of concrete either side having crumbled away.

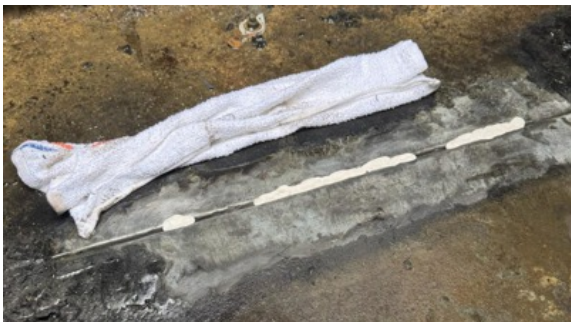
Superfast Aqua PW was forced into the crack, easily adhering to the saturated concrete to seal the leak

Because of its high wet surface adhesion properties, **Superfast Aqua PW Epoxy Putty** was used to seal the leak. The putty was mixed by hand and forced into the crack, curing to form a rock-hard material inside.

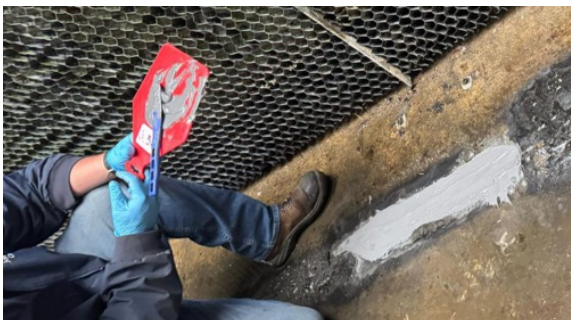
Industrial Metal Rapid rebuilt the floor around the crack where the concrete had crumbled away

Industrial Metal Rapid Epoxy Paste was then applied to rebuild the areas of missing floor around the crack. It filled the damage with a smooth, metallic-like material to further enhance the seal of Aqua PW.
