SYLWRAP Case Study

Crack Filled & Repair Disguised in Soil Pipe

A deep crack in a domestic soil vent pipe is sealed and the repair disguised by using Sylmasta AB Original Epoxy Putty to create an imitation sleeve joint

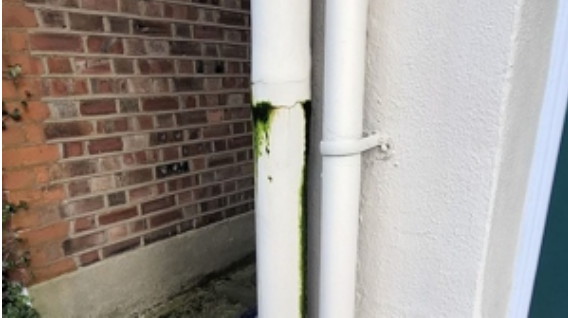
The soil pipe was leaking through an unsightly crack right next to a door into the house

The pipe was fixed to the wall next to a door into the house. It was leaking through a previous failed repair attempt made several years earlier.

Not only that, but the crack and surrounding damage was so unsightly that they naturally drew the eye of anyone coming in and out of the property.

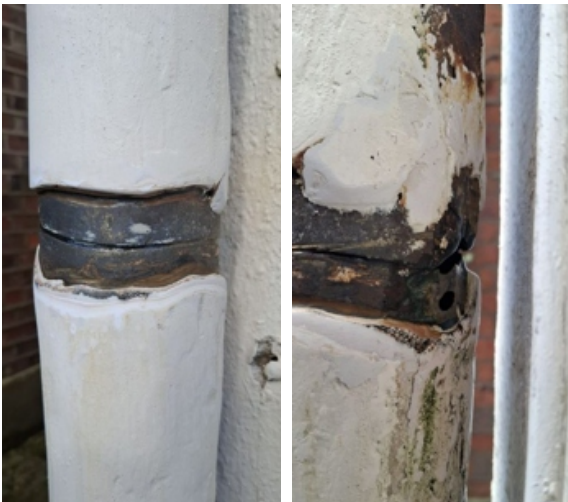
A previous failed repair attempt was ground away, creating a large groove around the crack which could be more easily filled with AB Original

As much of the original repair material was ground out as possible before a wider groove was created either side of the crack.

This made a larger repair area which was easier to fill with **Sylmasta AB Original Epoxy Putty**. It also provided a better key for the epoxy putty to bond with, improving adhesion with the pipe.

AB Original was mixed by hand. Whilst soft, it was packed tightly into the crack and groove to seal it.

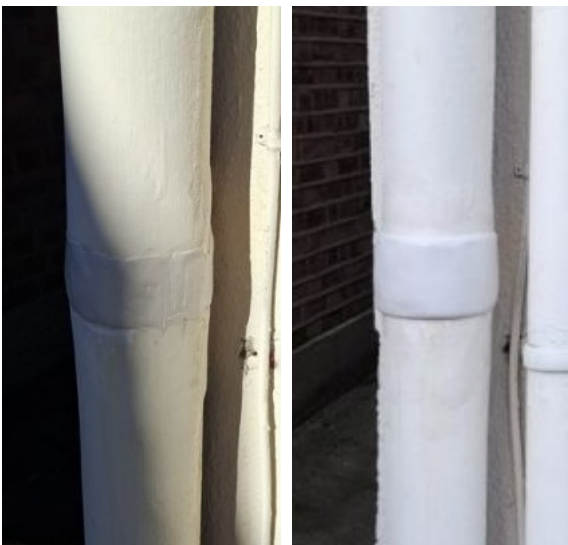
After the crack was filled, AB Original was formed into a band and bonded over the repair area to disguise it by resembling a step joint

More AB Original was then formed into a neat band. This band was placed around the diameter of the pipe, covering the repair area to resemble a joint.

Once AB Original reached maximum properties after 24 hours, it left the crack filled with a rock-hard material and a ring of epoxy putty bonded to the pipe which perfectly replicated the appearance of a sleeve.
