SYLWRAP Case Study

Chemical Plant Methanol Pipe Leak Repair

The rapid repair of a 3 bar leak in a 300mm stainless steel methanol pipe reduces downtime and lost production for a chemical plant in Saudi Arabia

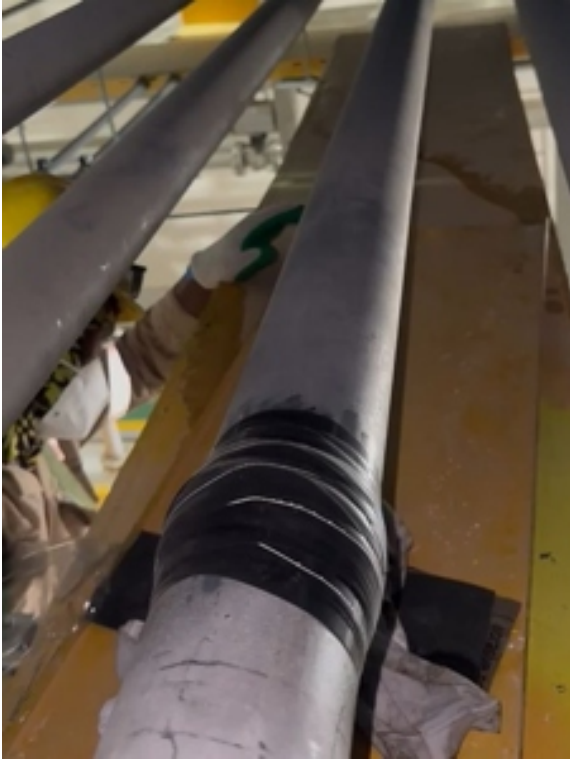
Wrap & Seal amalgamated to form a solid rubber band which contained the 3 bar methanol leak

Hamco engineers rushed to the plant with a **SylWrap Pipe Repair Contractor Case**. One 50mm x 4m **Wrap & Seal Pipe Burst Tape** was taken from the Case and applied over the leak.

Despite the space constraints, Hamco were able to stretch Wrap & Seal to its 300 percent maximum during wrapping. The tape amalgamated to create a solid rubber band containing the 3 bar methanol leak.

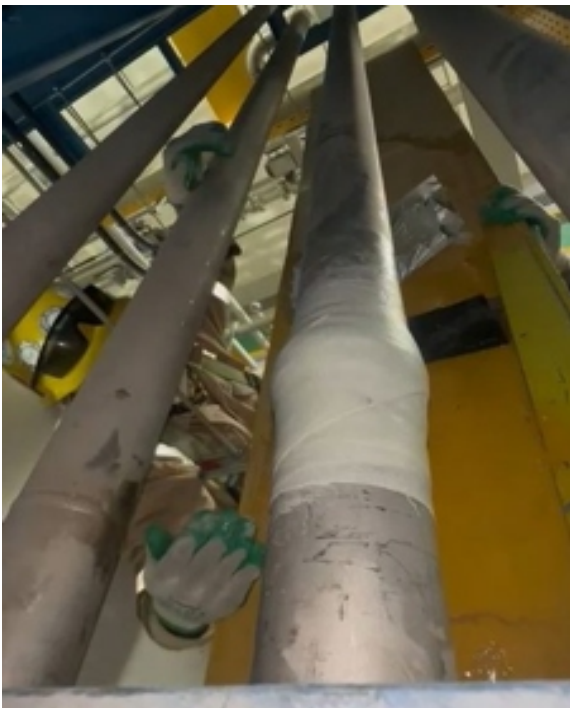
The repair was reinforced by using SylWrap HD to create a rock-hard shell around the pipe

The entire length of pipe was then reinforced with **SylWrap HD Pipe Repair Bandage**, which formed a rock-hard, impact resistant sleeve over the tape.

Once SylWrap HD cured, the system was turned on. The repair was a success with no methanol leaking.
