# SYLWRAP Case Study

## Pipe Flange Sealed Against Tree Root Ingress

After a tree penetrated a flange on an underground 1800mm steel pipe, a wastewater treatment plant seal the line to prevent future root ingress

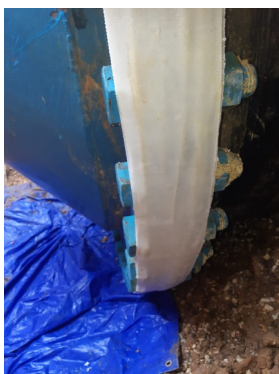
*A SYL412HD Bandage was the perfect 100mm width to wrap around the flange, curing to form a rock-hard shell which tree roots would not be able to penetrate in future*

A tree root had penetrated between two flange plates. The pipe was seeping and partly blocked, causing possible recontamination of water which had undergone most of the treatment process.

Once no more water was seeping from the flange, **SylWrap HD Pipe Repair Bandage** was applied over the top. A SYL412HD Bandage was used as its 100mm width fitted perfectly over the flange.

SylWrap Bandage cured to form a rock-hard shell around the flange. This reinforced the initial leak repair and ensured the line could not be penetrated through the weak spot between flange plates again.
