SYLWRAP Case Study

Pumping House 150mm Elbow Live Leak Repair

A water company in Malaysia make a live leak pinhole repair to a 150mm steel elbow pipe bend operating at 6 bar pressure at a pumping house

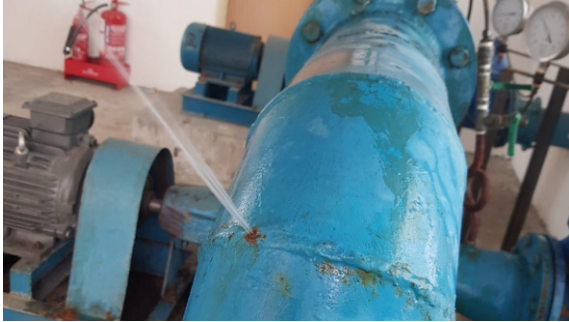
A pressurised jet of water was escaping the elbow bend at 6 bar through a pinhole left by corrosion

Corrosion had weakened the elbow where two sections of metalwork met at a welded joint, creating a pinhole leak. Water was spraying out from the pipe, which operated at 6 bar pressure.

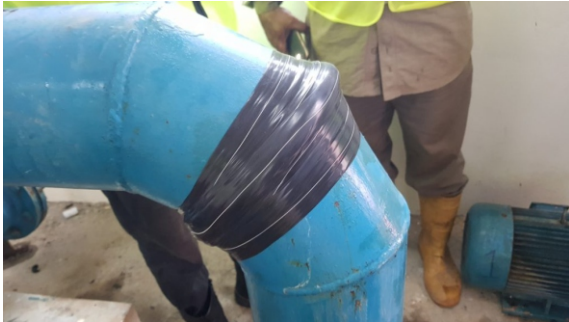
Wrap & Seal was stretched by 300 percent as it was wrapped around the pipe, amalgamating to itself to form a solid rubber band containing the 6 bar leak

Wrap & Seal Pipe Burst Tape was applied to seal the leak. The tape was stretched by the maximum 300 percent as it was wrapped, fusing to form a solid rubber band containing the 6 bar leak.

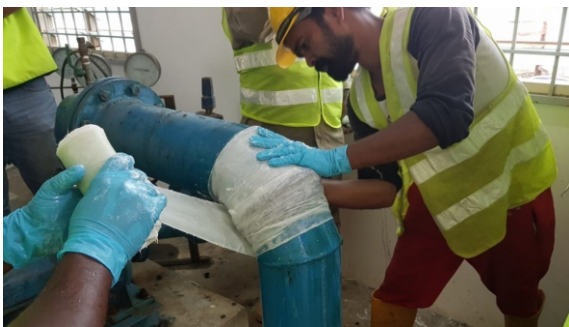
SylWrap HD reinforced the initial repair by creating a rock-hard, impact resistant sleeve around the pipe

The repair was reinforced using **SylWrap HD Pipe Repair Bandage**. SylWrap HD was wrapped and smoothed around the elbow, curing quickly to provide an impact resistant protective sleeve for the pipe.

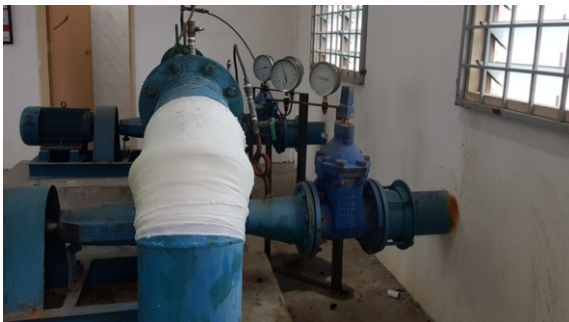
Repairing the elbow was completed in less than 30 minutes with no disruption to operations at the pumping house or local water supplies

Both products have WRAS approval, meaning they are safe to use with drinking water. The repair was completed in 30 minutes with no disruption to water supply or pumping house operations.
