SYLWRAP Case Study

Golf Club Repair Leaking Dishwasher Pipe

A dishwasher pipe at a golf clubhouse found leaking on a Sunday morning is repaired in under 30 minutes, ensuring no disruption to the lunchtime rush

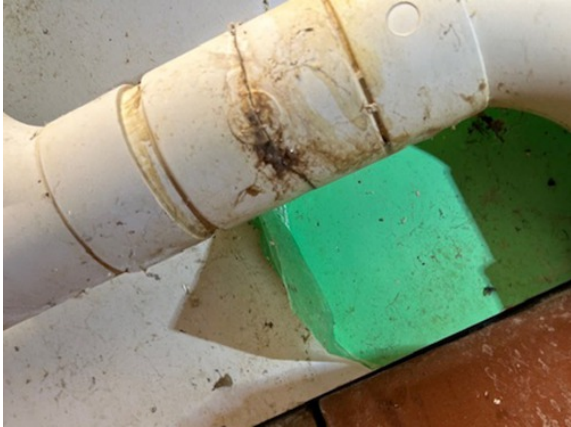
A 50mm plastic drain pipe connected to the back of the dishwasher was found to have a split around its entire diameter, leaking water all over the kitchen

Staff arrived at the golf club on Sunday morning to discover a 50mm plastic drain pipe at the back of the dishwasher leaking water all over the kitchen floor through a split in its diameter.

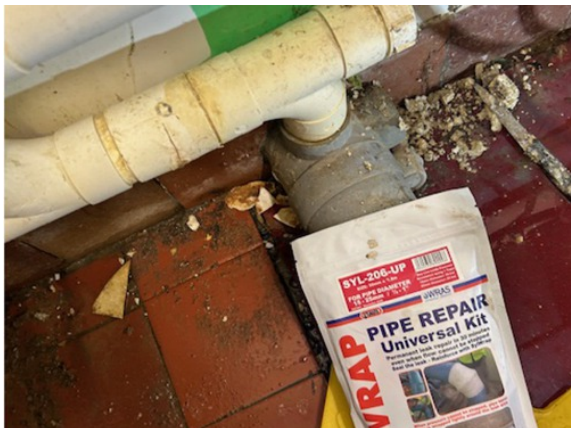
The golf club called their drainage contractor, who kept a stock of Sylmasta product on his van - including a SylWrap Universal Pipe Repair Kit

The club contacted the contractor who serviced their drains to see if he had a solution. The contractor kept a stock of Sylmasta products on his van, including a **SylWrap Universal Pipe Repair Kit**.

Wrap & Seal Pipe Burst Tape was wrapped around the entire diameter of the split. It fused together, forming a solid rubber band with pressure resistance to 25 bar; more than enough for the 2 bar drain pipe.

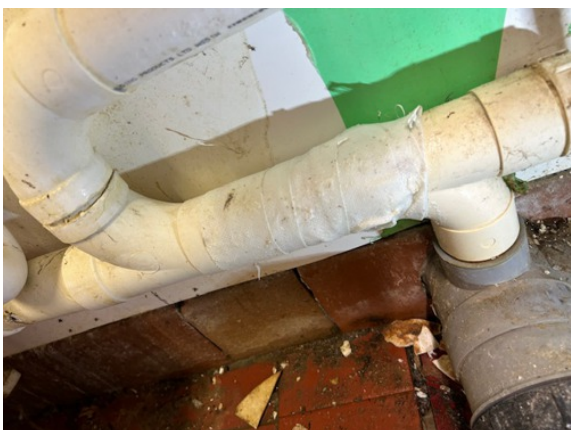
Wrap & Seal was wrapped around the split, sealing the leak. The repair was then completed with application of SylWrap HD to provide a rock-hard, impact resistant layer of protection

The repair was then reinforced with **SylWrap HD Pipe Repair Bandage**. After being activated with water, SylWrap HD set rock hard in minutes to provide an impact resistant layer of protection.
